Pressure mottling, also known as pressure marking or imprinting, is an inconsistent gloss pattern in the panel or flat sheet. Pressure mottling is flattening of the top coat (figure 1) which will appear as horizontal stripes in the panel face (photo 1) or a random pattern in the flat sheet (photo 2). Pressure mottling is normally caused by the stacked weight of the bundles or panels, but high temperatures and condensation in the stack can cause this also. This phenomena is most visible in dark, low gloss colors on non-embossed no profile panels or flat sheets. This is not a product defect and will dissipate over time. The coating will recover within a few days after the material is exposed to sun light or warm exterior temperatures (figure 2).

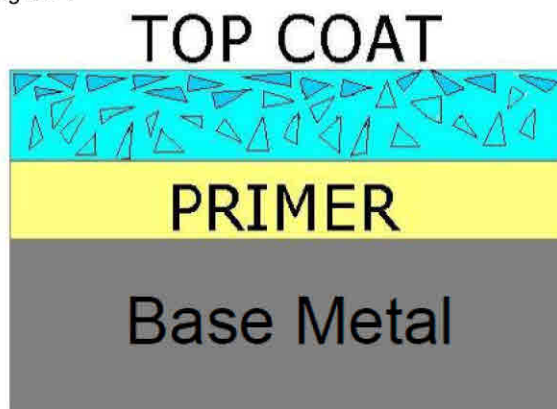
Figure 1

Sample crossview showing
"suppressed" gloss components

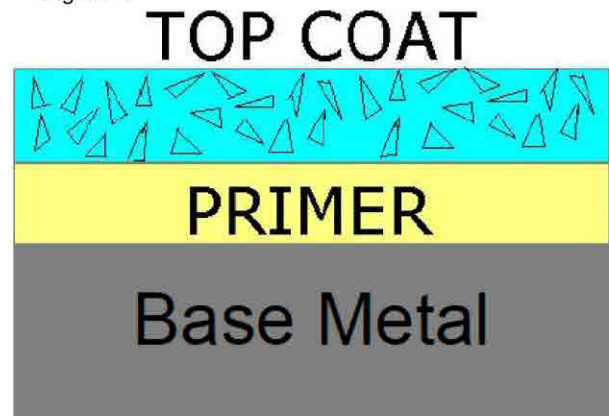
Figure 2

Sample crossview showing gloss
components in normal suspension
